BRT_TN_006

BT88x Errata Technical Note

Version 1.0

The intention of this errata technical note is to document a detailed description of known functional or electrical issues with the BRTChip's BT88x series devices, including BT880, BT881, BT882, BT883.

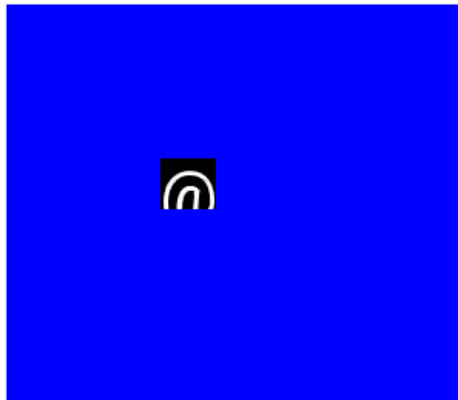
In the graphics engine, display list fetch is double-operation: the hardware fetches and decodes two 32-bit instructions per clock. When the **DISPLAY** instruction, which marks the end of display list, is placed in an even slot, the following instruction in the odd slot is erroneously fetched and can be partially executed by some bitmap pipeline stages. The table below shows the layout of **RAM_DL** content when the issue happens:

The specific problematic instruction is **BITMAP_SIZE**. If it occurs after the **DISPLAY** instruction, it is executed by the graphics engine, and erroneously sets the height parameter of current bitmap handle. Consequently, the rendered image associated with the impacted bitmap handle could be enlarged or shortened vertically.

Since instruction 7 is partially executed, the height parameter of **BITMAP_SIZE** is set to 33:

Identify the end of display list and append it with an *additional* **DISPLAY** instruction, guaranteeing that the erroneous fetch (if any) does nothing. For example:

At instruction 7, an additional **DISPLAY** instruction is added, which prevents the unexpected impact of erroneously fetched instruction.

In this scenario, the workaround is to reset **RAM_DL** to zero before initiating the display list, effectively populating **RAM_DL** with **DISPLAY** instructions. For example:

Coprocessor command **CMD_MEMZERO** is added to reset the **RAM_DL** to zero, which guarantees the display list is ended with at least two **DISPLAY** instructions.
