Technical Note

TN_159

FT90x Errata

Version 1.2

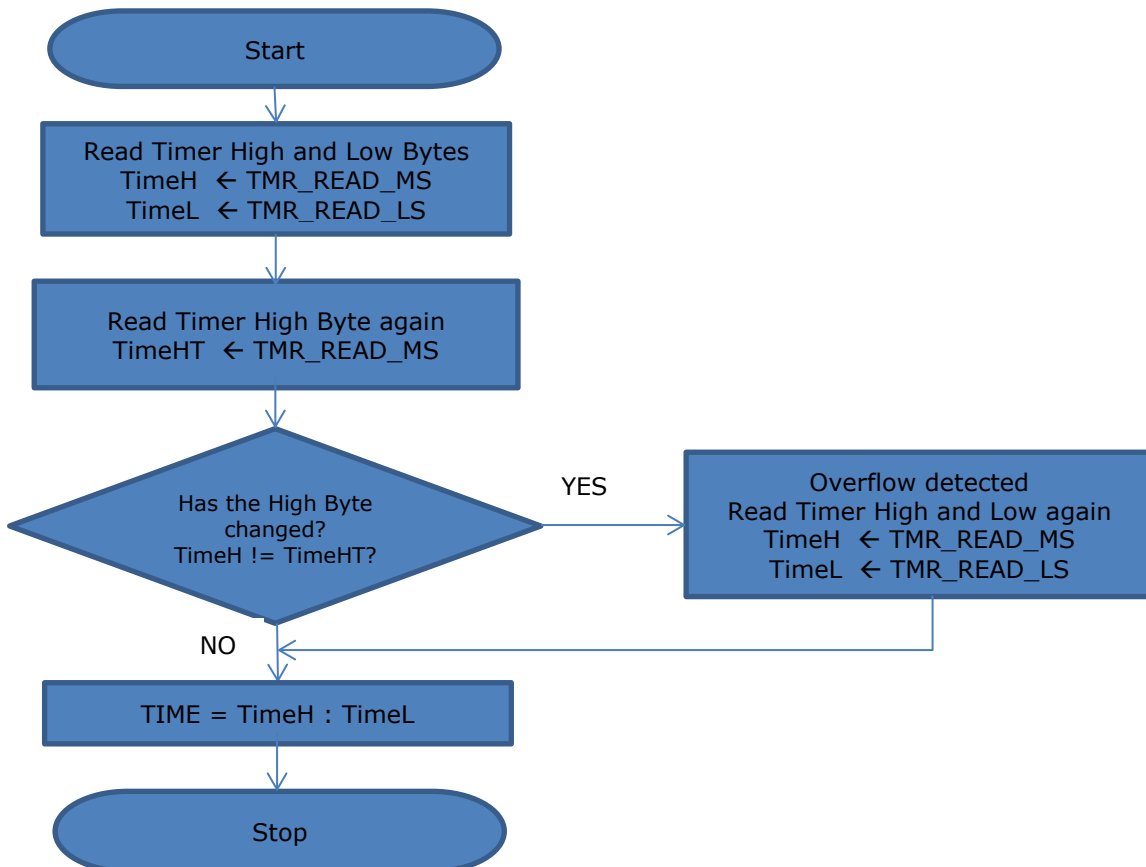
Figure 4.1 - Timer Read taking overflows into account

If either of the 8-bit registers overflows during the read, the resulting concatenated 16-bit value will be incorrect as illustrated in **Table 6**.

The workaround for this is to read the high byte twice to check if there was an overflow while the low byte was being read as shown in Error! Reference source not found..

Note: Users must also take care that the above read sequence is not interrupted, as that could potentially lead to inconsistent values.

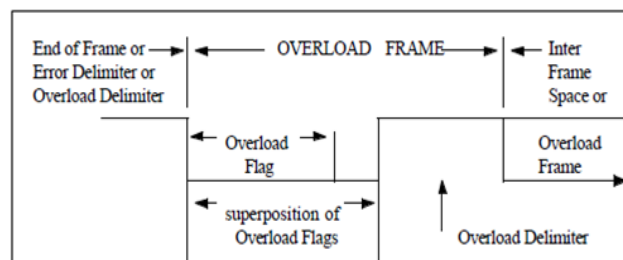
Figure 4.2 - CAN OVERLOAD Frame

The CAN controller violates the behavior described in the specification. Instead of sending the OVERLOAD FRAME immediately after the End of Frame, the CAN controller adds one extra 'recessive' bit (1'b1) between the End of Frame and the OVERLOAD FRAME.

Currently, there is no workaround for this issue.

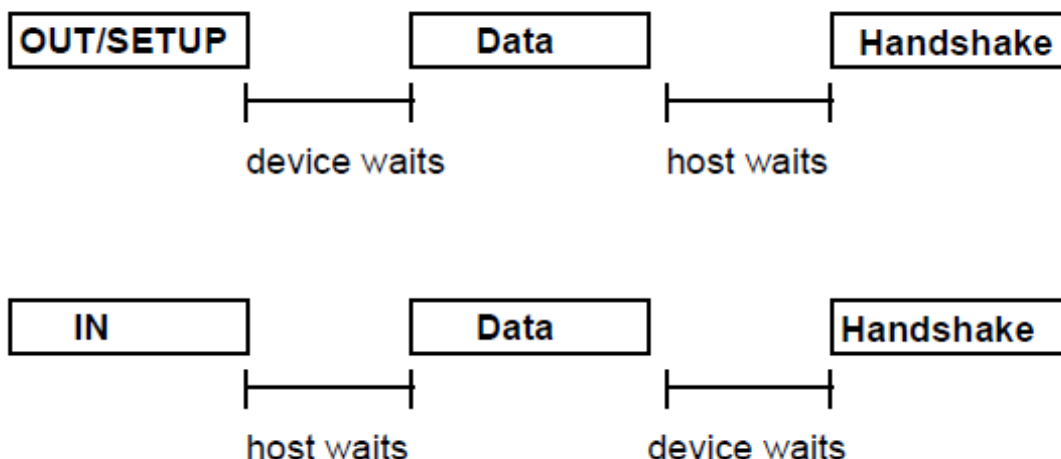
Figure 4.4 - Bus Turn-around Timer Usage (copied from USB 2.0 Specification)

The USB Device Controller doesn't check for bus turn-around timeout between OUT/SETUP token and data phases. It will accept the data and respond with ACK.

Currently, there is no workaround for this issue.
